DEPARTMENT OF TRANSPORTATION**DIVISION OF ENGINEERING SERVICES**

Quality Assurance and Source Inspection

Contract #: 04-0120F4Cty: SF/ALA Rte: 80 PM: 13.2/13.9File #: 69.15**SOURCE INSPECTION REPORT****Resident Engineer:**Pursell, Gary**Address:** 333 Burma Road**City:** Oakland, CA 94607**Report No:** SIR-000008**Date Inspected:** 13-Jan-2007**Project Name:** SAS Superstructure**OSM Arrival Time:** 700**Prime Contractor:** American Bridge/Fluor Enterprises, a JV**OSM Departure Time:** 1530**Contractor:** Zhenhua Port Machinery Company, Ltd (ZPMC), Changxing Island **Location:** Shanghai, China**Quality Control Contact:** Liu Liu**Quality Control Present:** Yes No**Material transfer:** Yes No N/A**Sampled Items:** Yes No N/A**Stock Transfer:** Yes No N/A**OK to Cut:** Yes No N/A**Rebar Test Witness:** Yes No N/A**Delayed/Cancelled:** Yes No N/A**Other:** Review of radiographic testing**Bridge No:** 34-0006**Component:** Procedure Qualification test plate**Bid Item:** N/A**Lot No:** N/A**Summary of Items Observed:**

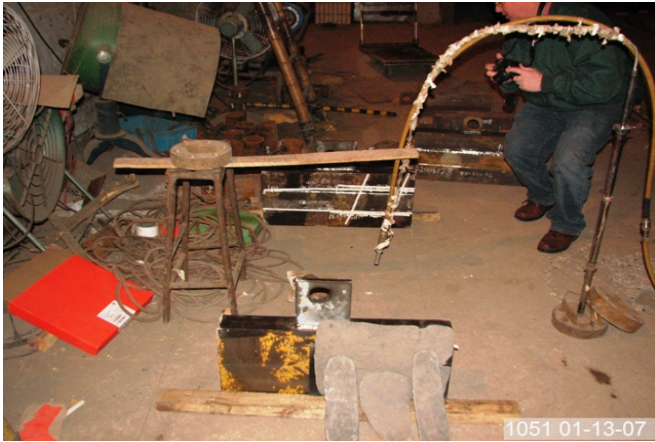
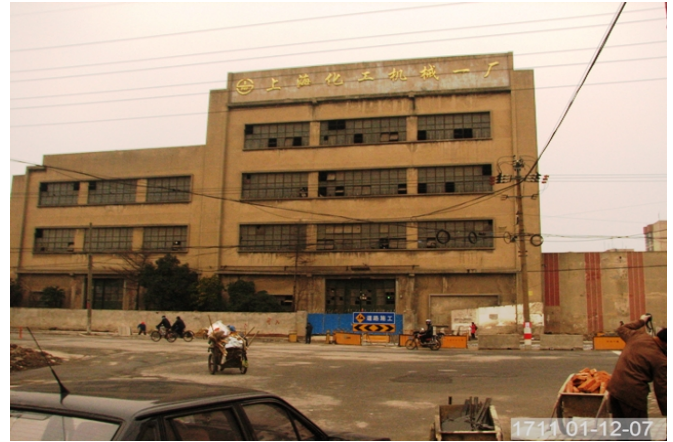
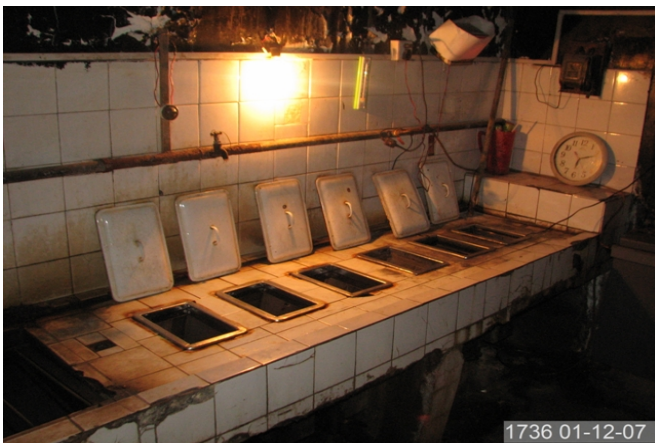
On this date the QA representative Joe Lanz arrived at Jin Tong Jian Chen NDT Company LTD. of Shanghai China perform a review of radiographic testing of procedure qualification test plates performed by Zhenhua Port Machinery Company (ZPMC). The test plates were radio graphed by Jin Tong Jian Chen NDT Company LTD. of Shanghai China. The QA inspector observed the start of radiography. The exposures were performed utilizing the following. 1) Source, Cobalt 60, serial number C63535, size of 3mm by 2mm, 8 curies placed on the center line of the weld at 300mm source to object distance. The geometrical unsharpness was calculated to be .019. 2) On the 75mm thick test plates, two each number 45 IQIs were placed on source side at the weld with the smallest weld facing to the end of the weld. 3) The film utilized appeared to be 17 inch by 7 inch AGFA C7. Work was not completed on this shift and appears to be in general compliance with contract documents and AWS D1.5-2002. See the pictures below.
